**DEPARTMENT OF TRANSPORTATION**

Contract #: 04-0120F4Cty: SF/ALA Rte: 80 PM: 13.2/13.9File #: 99.28**WELDING INSPECTION REPORT****Resident Engineer:** Siegenthaler, Peter**Address:** 333 Burma Road**City:** Oakland, CA 94607**Report No:** WIR-020096**Date Inspected:** 03-Feb-2011**Project Name:** SAS Superstructure**OSM Arrival Time:** 700**Prime Contractor:** American Bridge/Fluor Enterprises, a JV**OSM Departure Time:** 1500**Contractor:** Zhenhua Port Machinery Company, Ltd (ZPMC) Chanxing Island**Location:** Shanghai, China

**Bridge No:** 34-0006**Component:** OBG Segment**Summary of Items Observed:**

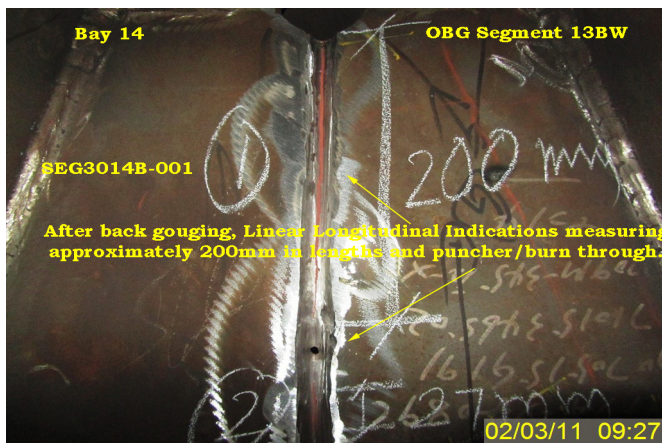
During the Quality Assurance random visual inspection of welds located on Floor beam, deck panel diaphragm welds of OBG Segment 13BW, this Quality Assurance Inspector (QA) observed the following issues;

- Linear Longitudinal Indications measuring approximately 200mm in lengths and punctured/burn through.
- After back gouging, these indications were discovered visually and confirmed by Magnetic particle Testing (MT) by ZPMC MT personnel.
- The indications are clearly marked on the material near the weld for further repair. The weld number is identified as SEG3014B-001. The panel point is identified as a PP122.
- This weld is a CJP weld joining the Deck Panel Diaphragm to Deck Panel Diaphragm.
- The Deck Panel Diaphragm to Deck Panel Diaphragm weld is identified as Seismic Performance Critical Member (SPCM).
- The cracks are completely removed and re-weld shall be performed as per required contract document and approved WPS. For further information, Please see attached pictures.

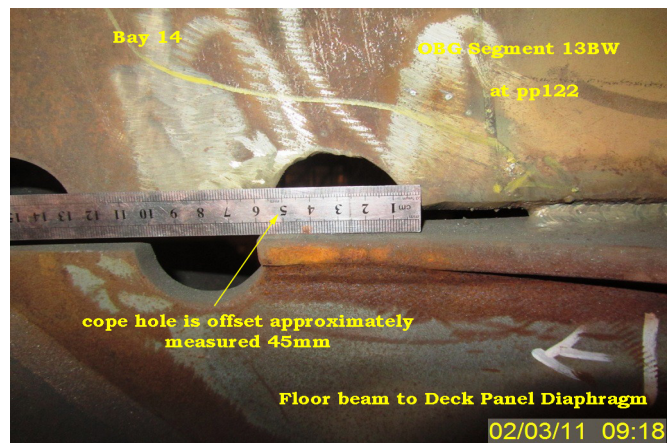
During the Quality Assurance random visual inspection of welds located on Floor Beam at panel point 122 bike path side of Segment 13BW, this Quality Assurance Inspector (QA) observed the following issues;

- Offset in a cope hole located at Floor beam to Deck Panel Diaphragm.
- The offset is measured approximately 45mm in length.
- The floor beam number is identified as FB3204A and Deck Panel is identified as DP3137A.
- Floor Beam and Deck Panel Diaphragm are identified as Seismic Performance Critical Member (SPCM). OBG
- Segment 13BW is located West Side of Bay 14 area.
- According to the contract document ZPMC personnel need to submit Critical Weld Repair to the engineer prior to weld repair. For further information, Please see the attached pictures.
